# NATIONAL ADVISORY COMMITTEE FOR AERONAUTICS

No. 1464

EFFECTS OF SURFACE FINISH, OF CERTAIN DEFECTS, AND OF REPAIR  
OF DEFECTS BY WELDING ON FATIGUE STRENGTH OF 355-T6  
SAND-CASTINGS AND EFFECTS OF PRIOR FATIGUE  
STRESSING ON TENSILE PROPERTIES

Aluminum Company of America

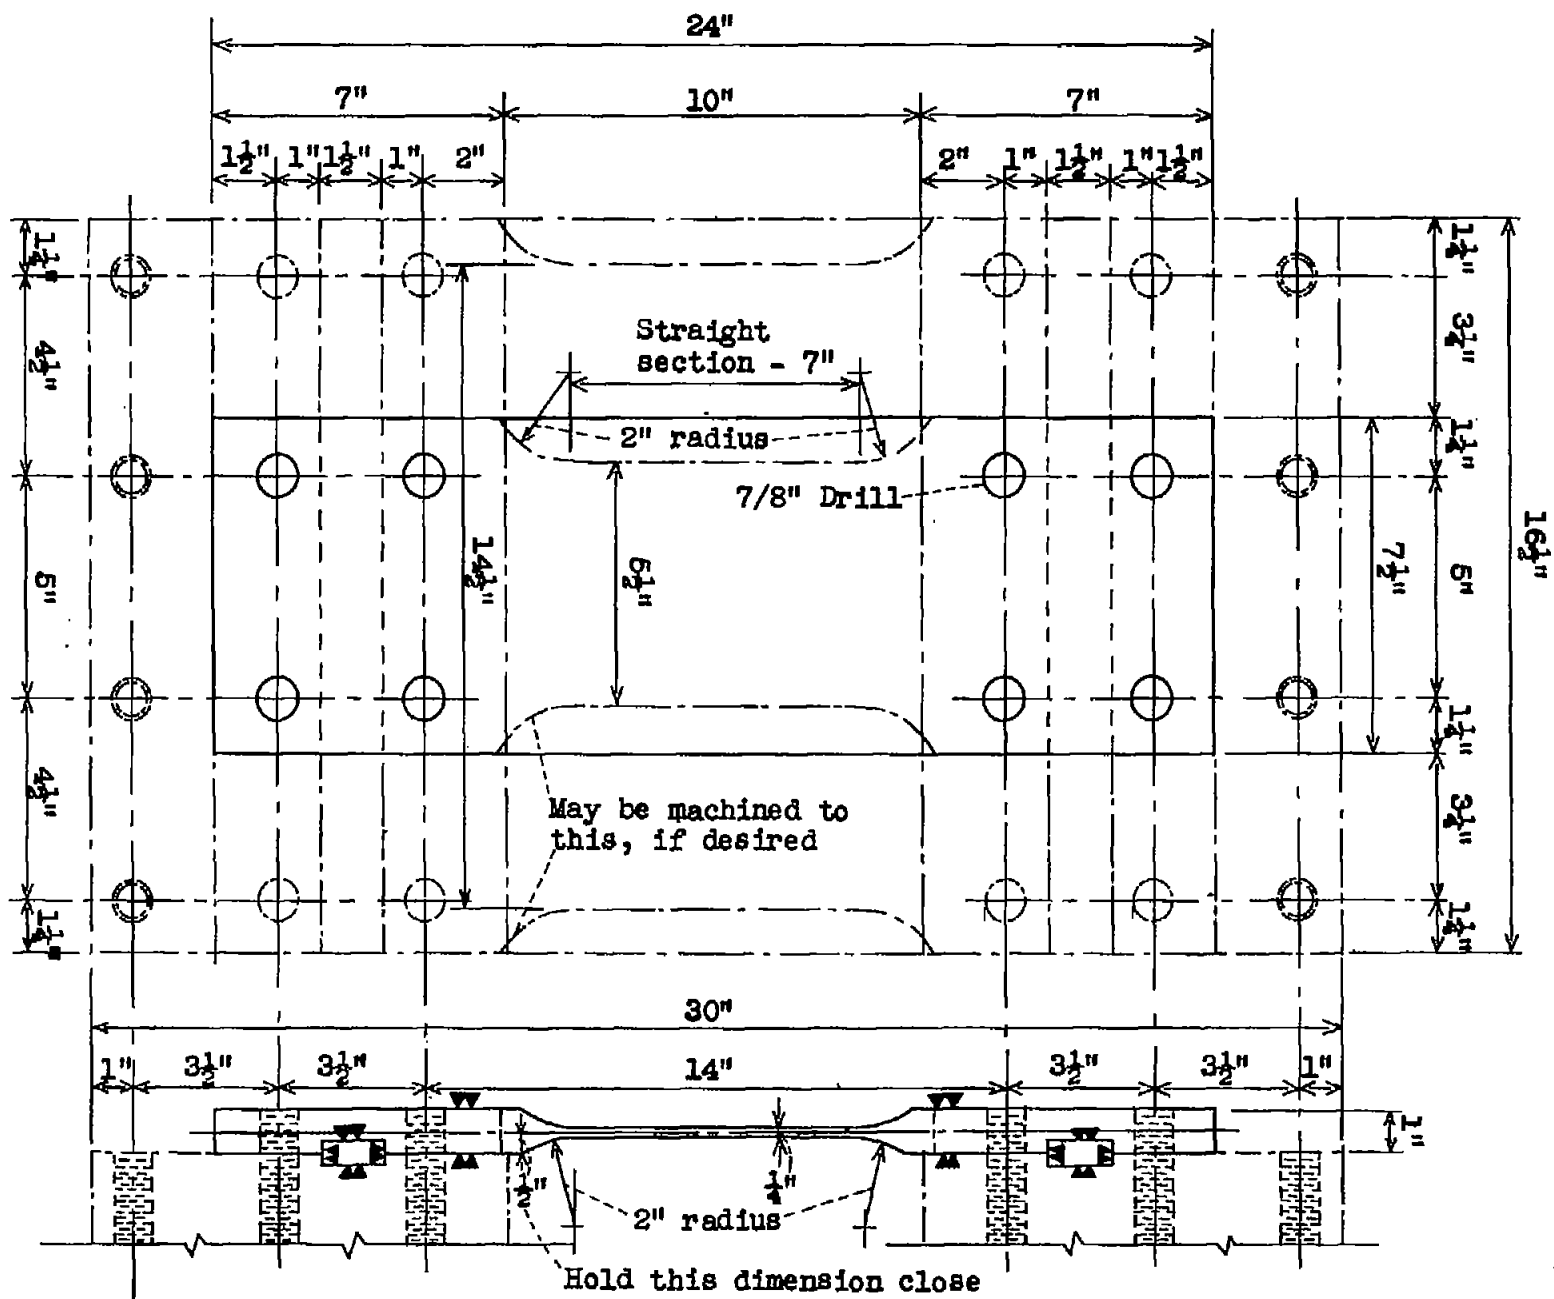
Figure 1.- Specimen for structural fatigue testing machine.

The specimens used for this investigation were sand-cast plate-type specimens of the general design shown in figure 1. The reduced sections were about  $\frac{1}{4}$  inch thick and, in general,  $7\frac{1}{2}$  inches wide, although a few were only  $5\frac{1}{2}$  inches wide. Most of the specimens were tested with the surfaces of the reduced section as-cast; those that were tested with machined surfaces were cast with a reduced section about  $\frac{1}{2}$  inch thick and machined to a thickness of  $\frac{1}{4}$  inch. The thickness of the reduced sections was from 0.010 to 0.058 inch less at the center than at the ends. Fourteen lots of castings were prepared. A brief description of each lot is given in table I.

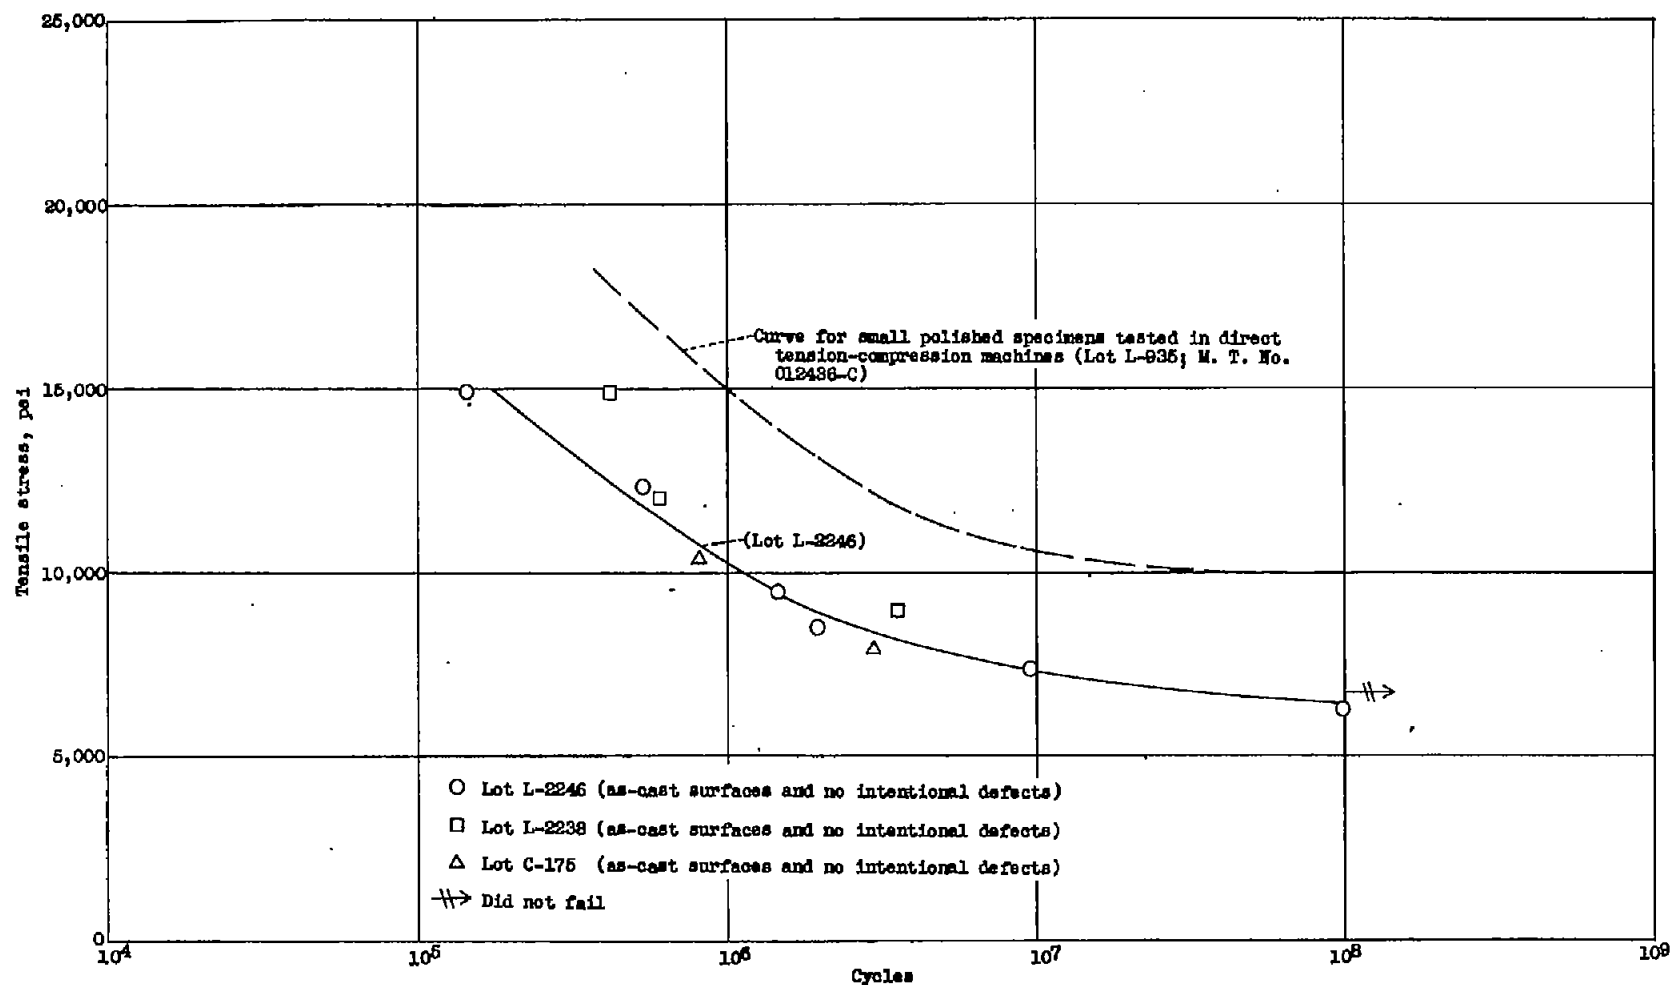
Figure 5(a).- Direct-stress fatigue curve for 355-T6 sand-cast specimens. Ratio of minimum stress to maximum stress equals zero.

The individual test data for the specimens with as-cast surfaces and without intentional defects are summarized in table III and are plotted in figure 5(a). The solid curve has been drawn through the points representing specimens from lot L-2246 and is in good agreement with the results of tests of the other two lots, L-2238 and C-175. As a basis for comparison, this curve is also shown in figures 5(b) to 5(g). The fatigue strength at 25,000,000 cycles was 6900 psi. This is about 20 percent of the tensile strength determined from  $\frac{1}{2}$ -inch-diameter test bars from lot L-2246. For comparison, the curve obtained in similar direct-stress fatigue tests of small polished specimens of the same alloy is also shown in figure 5(a). As might be expected, the fatigue curve for the large specimens with as-cast surfaces is considerably below the curve for the polished specimens.

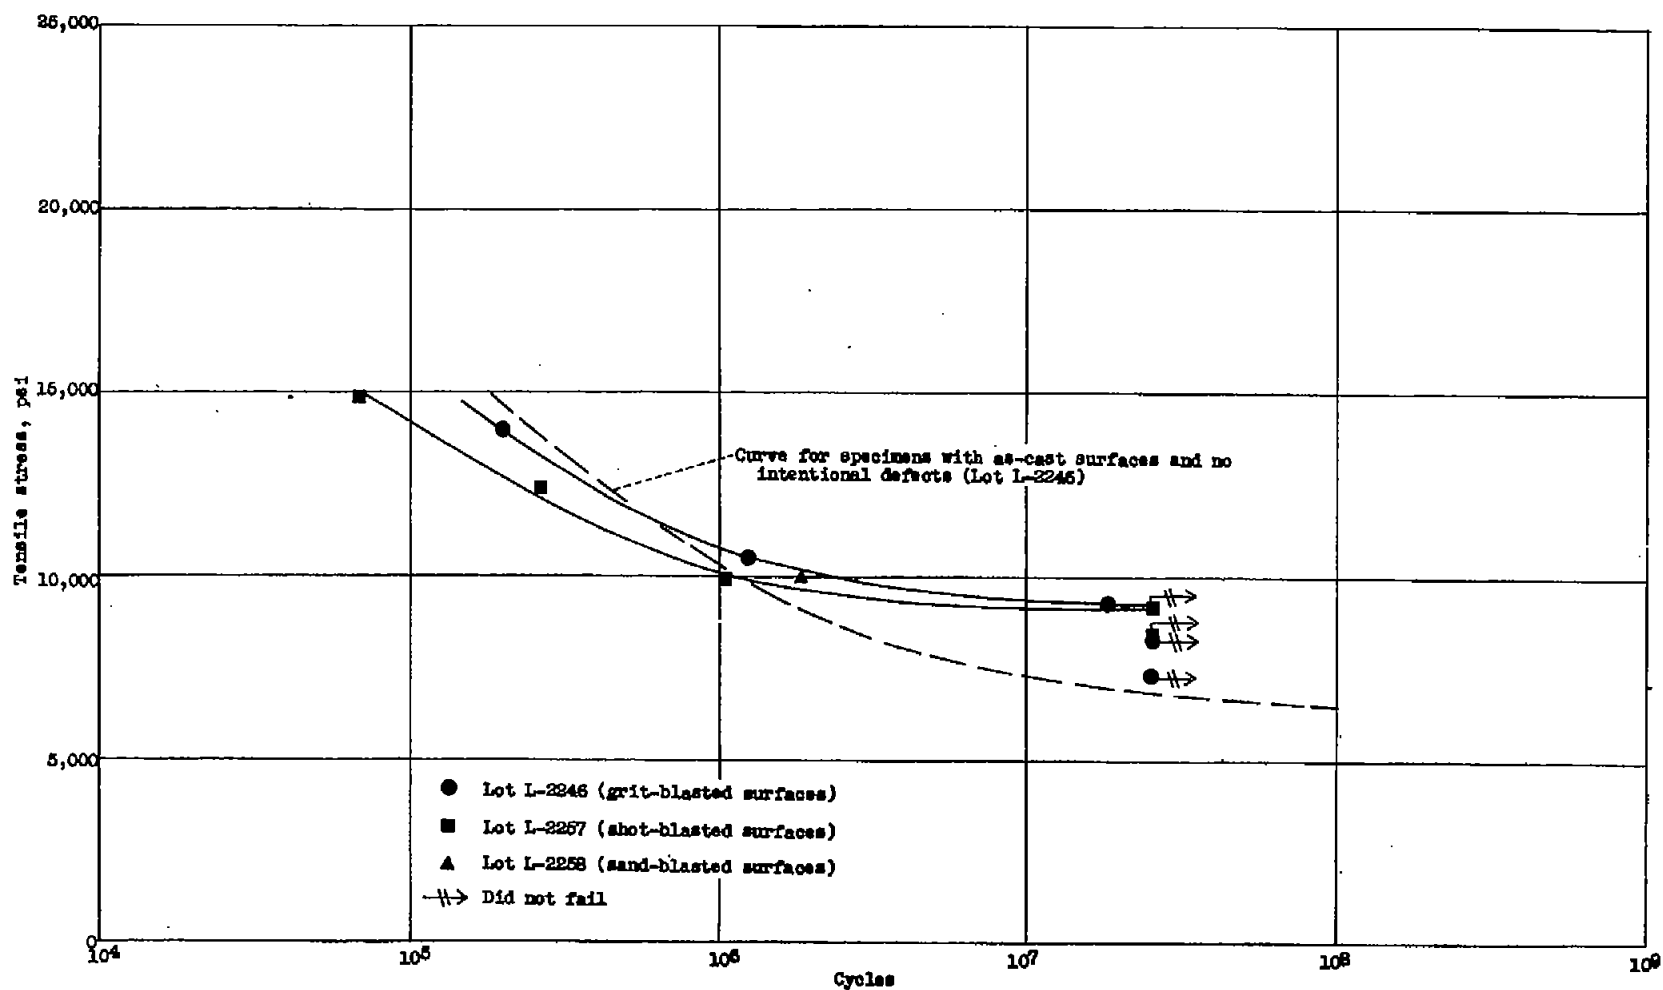
Figure 5(b).- Direct-stress fatigue curves for 355-T6 sand-cast specimens. Ratio of minimum stress to maximum stress equals zero.

The effects of surface treatments, such as grit-blasting and shot-blasting, are shown in figure 5(b). The curves indicate rather definitely that, at stresses below 10,000 psi, both grit-blasting and shot-blasting improve the fatigue strength considerably. The fatigue strengths of the grit-blasted and shot-blasted specimens each were about 9300 psi at 25,000,000 cycles or an increase of about 35 percent over that of specimens having as-cast surfaces. One test of a sand-blasted specimen was made, and the results of it also are shown in figure 5(b). The results of this test indicate that the effect of sand-blasting is about the same as that of grit- and shot-blasting.

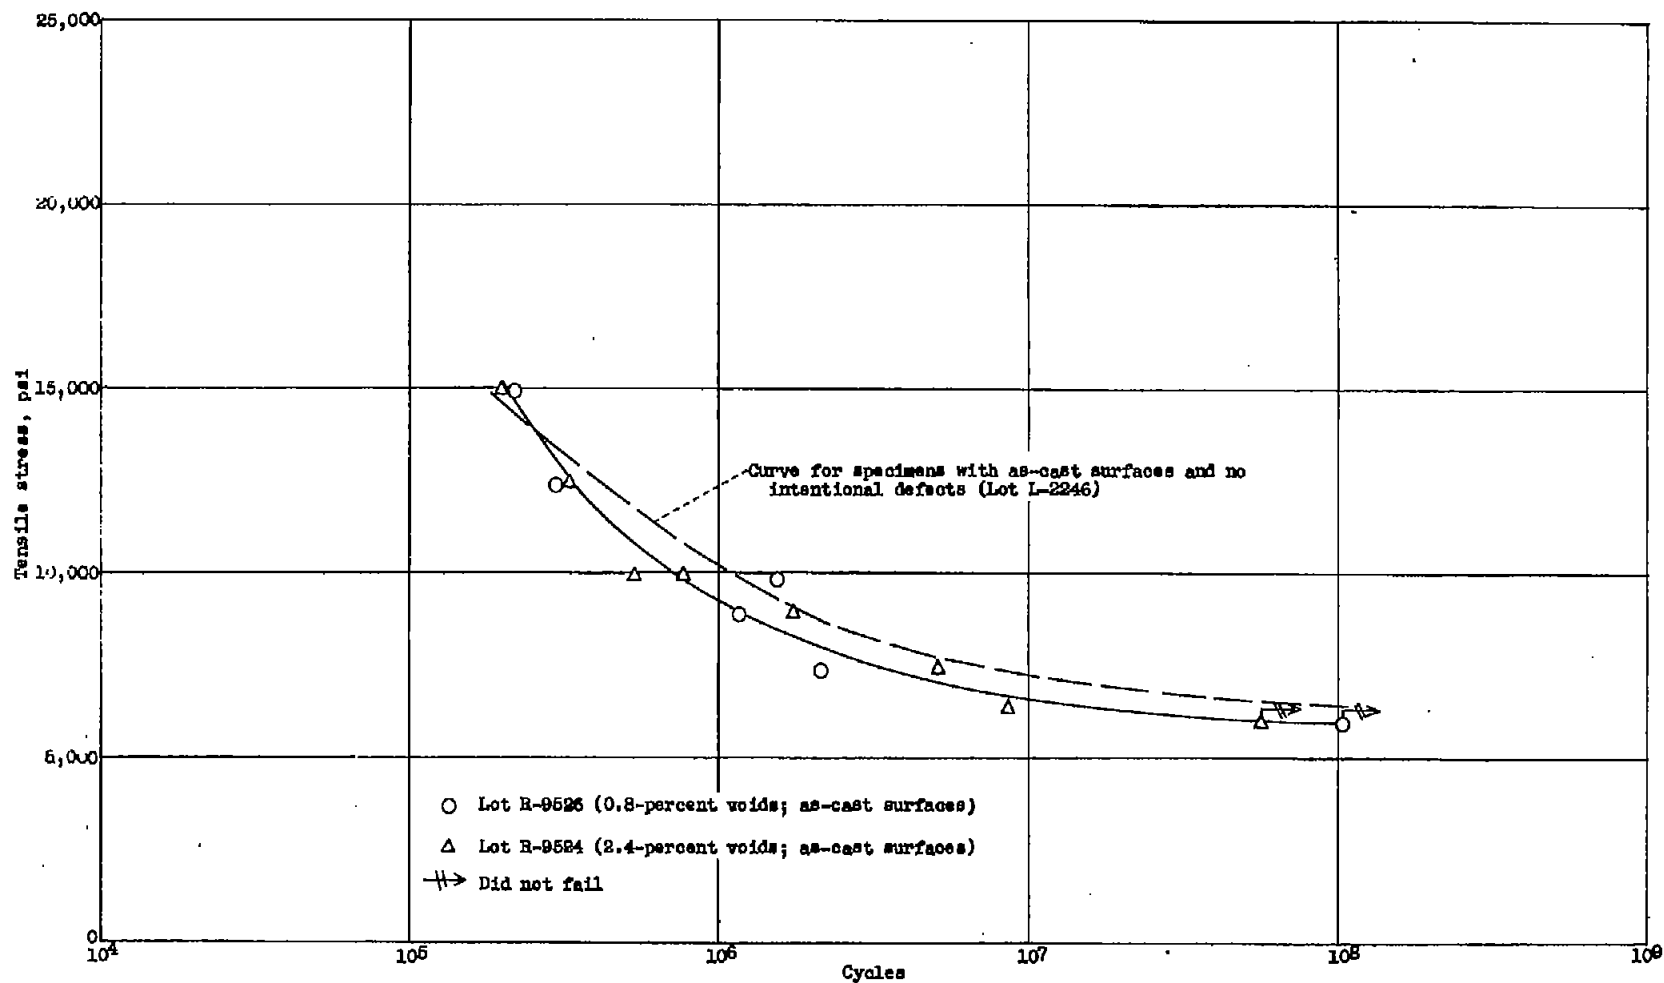
Figure 5(c).- Direct-stress fatigue curves for 355-T6 sand-cast specimens. Ratio of minimum stress to maximum stress equals zero.

The data for specimens containing two degrees of porosity, about 0.8 and 2.4 percent, respectively, are shown in table V. A porosity of 0.8 percent represents about the maximum commercial quality, and a porosity of 2.4 percent represents the minimum quality. There were two groups of castings with each degree of porosity, one tested with as-cast surfaces and one with machined surfaces. The results of the tests of the specimens with as-cast surfaces are plotted in figure 5(c) and indicate no definite difference in fatigue strength. The results for the specimens with machined surfaces are plotted in figure 5(d) and indicate large differences. Although the specimens with the smaller degree of porosity had about the same fatigue strength as that of specimens with as-cast surfaces and no intentional defects, those with the larger degree of porosity had considerably lower fatigue strength. The machining probably made any notch effect of the pores more harmful, for the metal removed from the surface during machining would be less porous than that at the center.

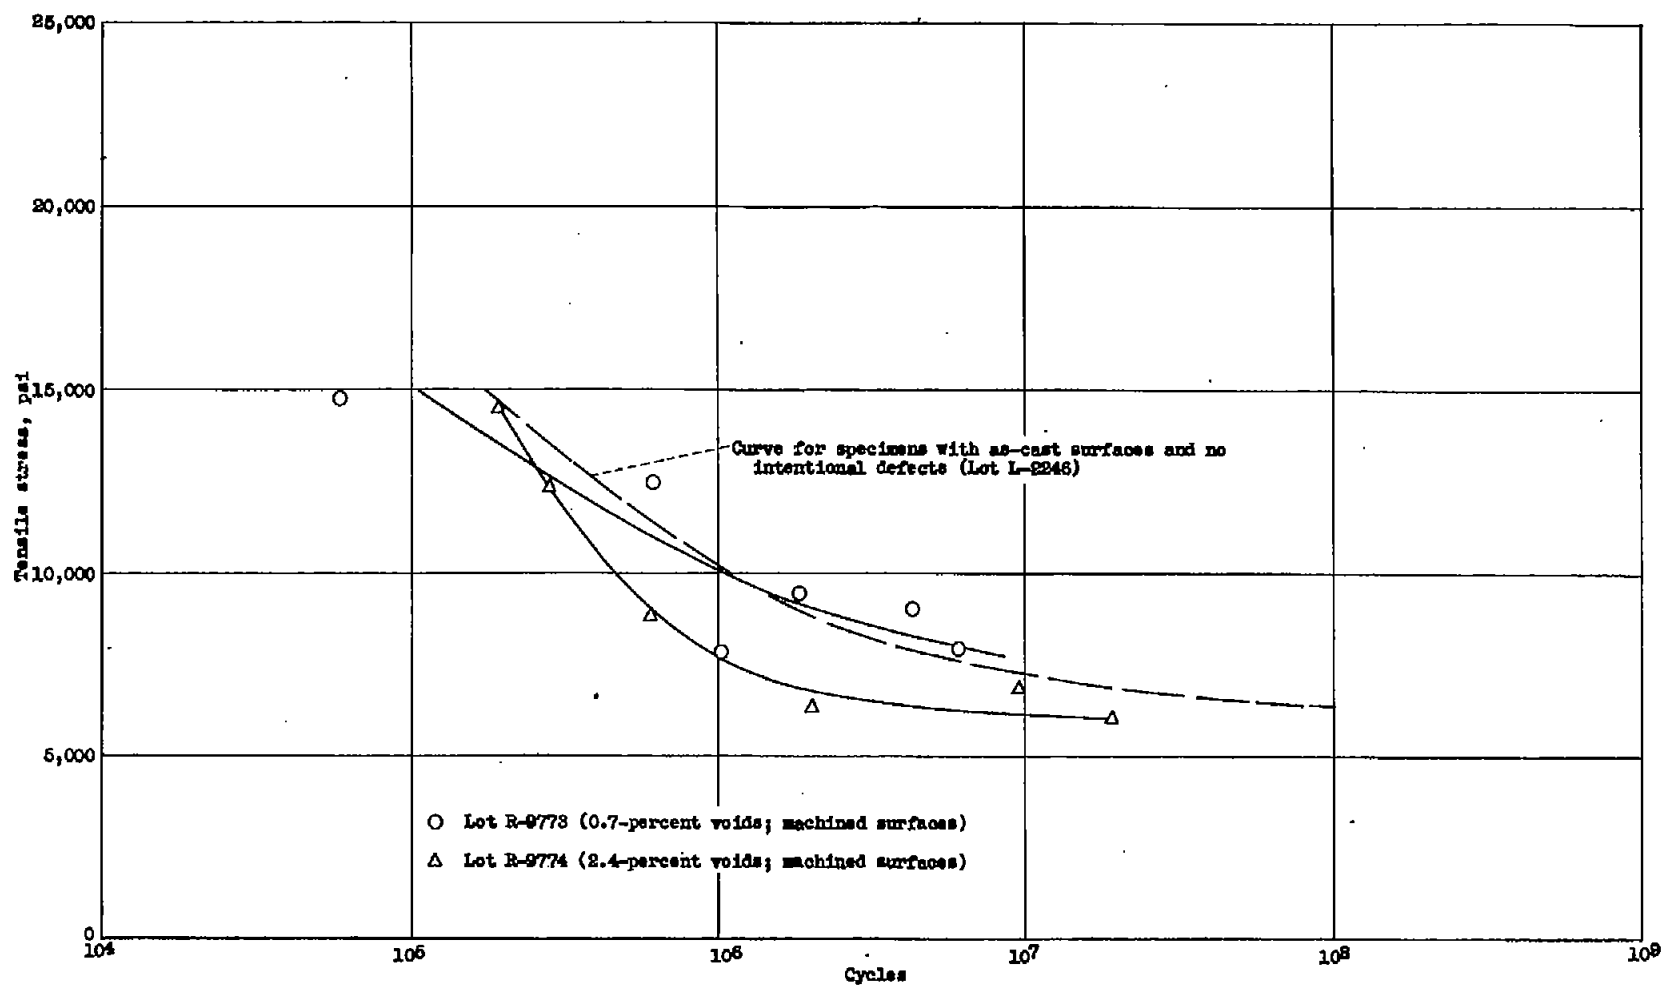
Figure 5(d).- Direct-stress fatigue curves for 355-T6 sand-cast specimens. Ratio of minimum stress to maximum stress equals zero.

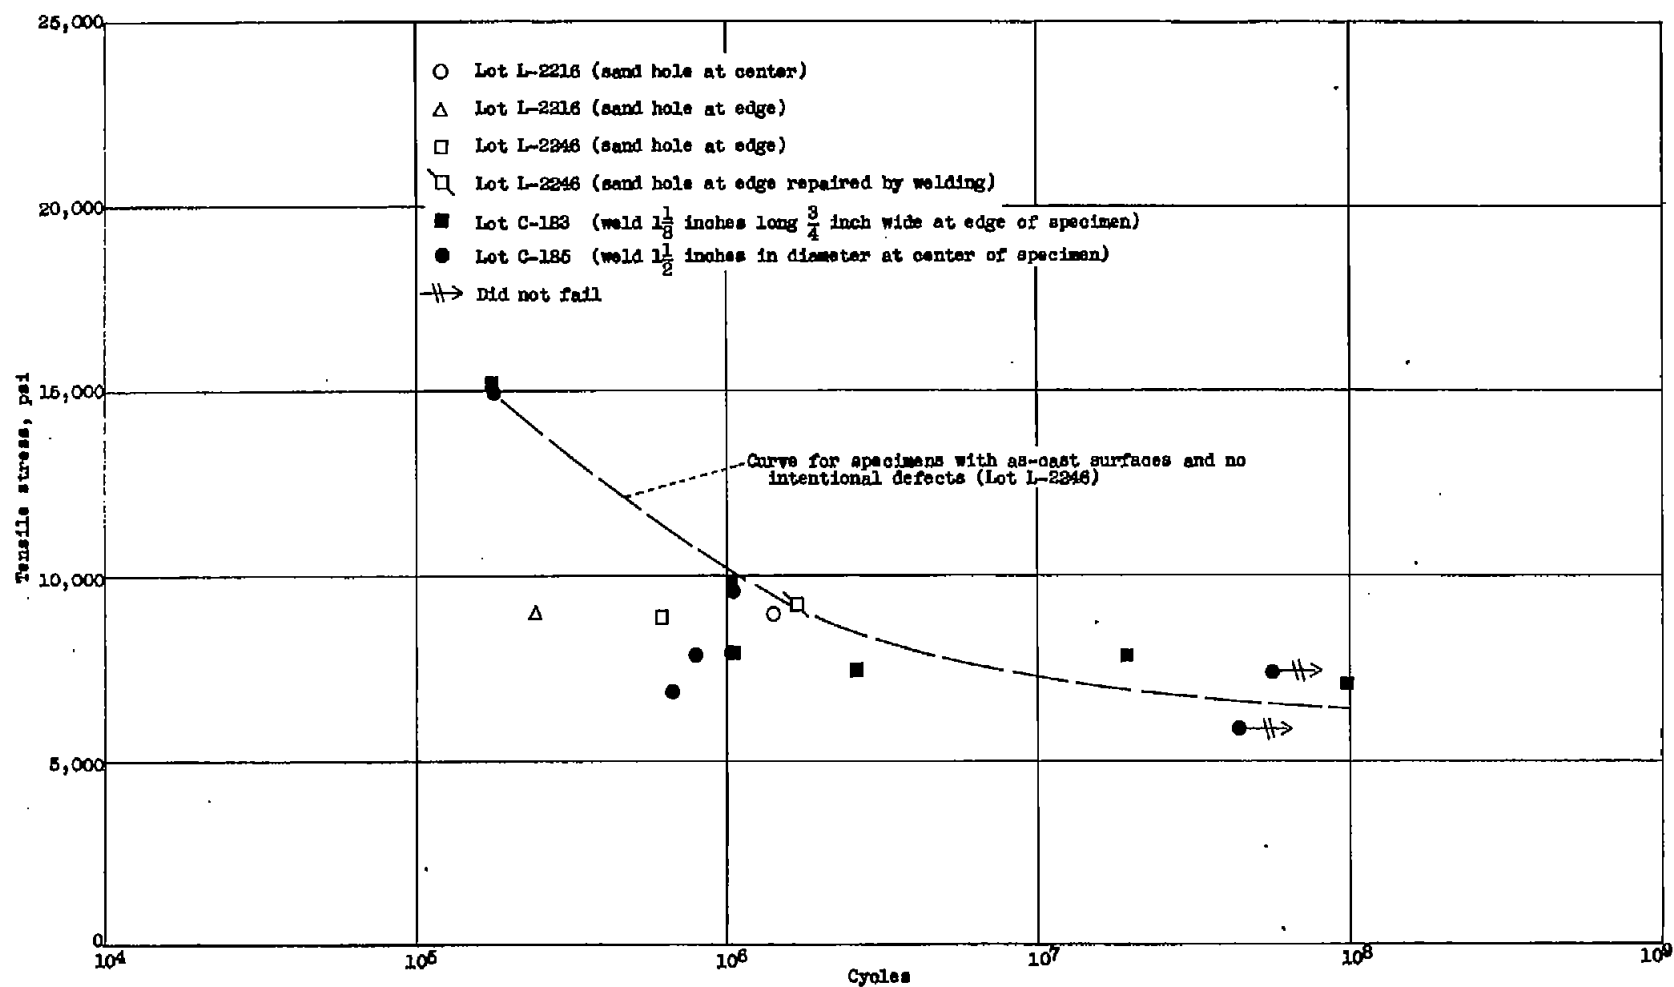
Figure 5(e).- Direct-stress fatigue curve for 355-T6 sand-cast specimens. Ratio of minimum stress to maximum stress equals zero.

The results of tests made to study the effects of certain casting defects upon fatigue resistance are shown in figure 5(e). Included also are the results of tests of specimens with defects repaired by welding. In three tests the specimens contained sand holes,  $\frac{1}{4}$  inch in diameter and  $\frac{1}{8}$  inch deep, the sand holes being at the edge in two specimens and at the center of the other one. These three tests indicate that sand holes affect the fatigue strength of the castings and are more harmful when at the edge of the test section than when at the middle. One test was made in which a sand hole at the edge of the specimen had been repaired by welding. The results indicate the fatigue strength to be about the same as that of specimens free from defects. Six tests were made on specimens having a weld about  $1\frac{5}{8}$  inches long and  $\frac{3}{4}$  inch wide at the edge of the test section, and seven tests were made on specimens with a weld about  $1\frac{1}{2}$  inches in diameter at the center of the section. These specimens were heat-treated after welding, and when checked radiographically the welds were found to be sound. Although there was some scatter, the test results indicate that it is possible by welding to restore the fatigue resistance of castings containing defects. This, however, was not accomplished in every case. The improvement resulting from welding would be expected to be dependent upon the size and character of the defect and the quality of the weld. In 9 of the 12 welded specimens that failed, the failures occurred through the weld or at the edge of the weld.

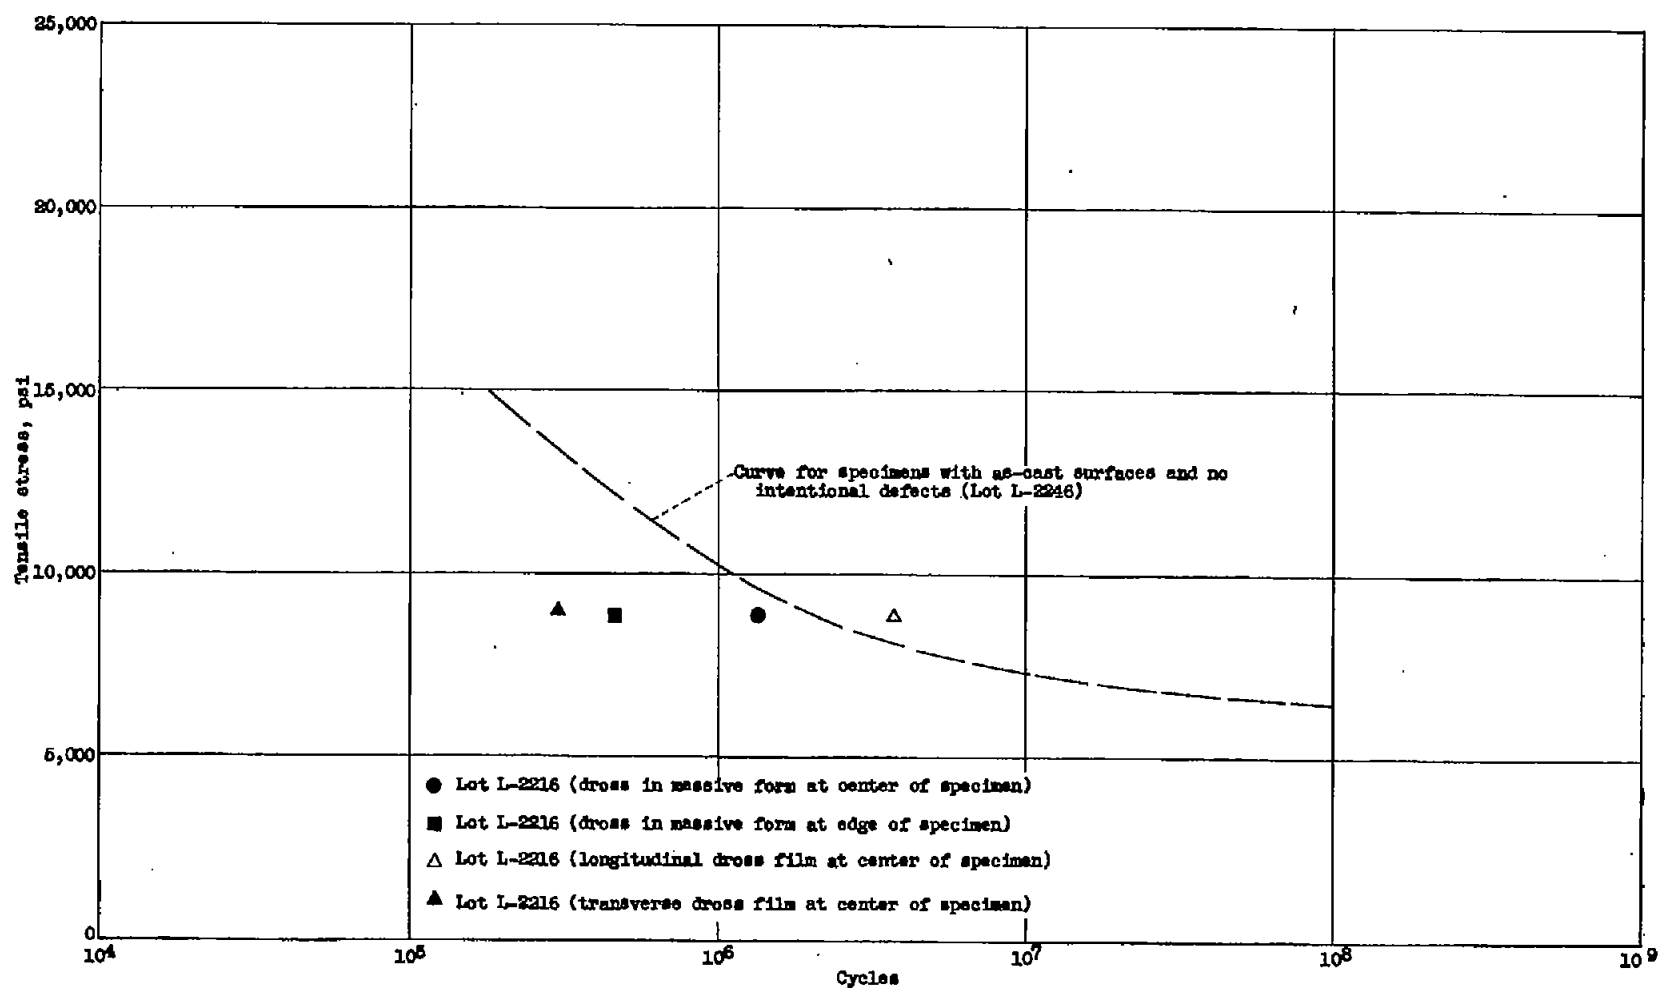
Figure 5(f).-- Direct-stress fatigue curve for 355-T6 sand-cast specimens. Ratio of minimum stress to maximum stress equals zero.

The results of tests of four specimens with several types of dross inclusion are shown in figure 5(f). In two of the specimens the dross was in massive form, and in the other two it was present in the form of a film. In the specimens containing dross in massive form, the dross was at the edge of one specimen and in the center of the other. In the specimens containing dross in the form of a film, the film extended transversely at the center of one specimen and longitudinally at the center of the other. All four tests were made at the same stress, 9000 psi. They indicate that dross inclusions at the edge of a specimen are more harmful than those at the center. Also, dross films in the transverse direction are more harmful than those in the longitudinal direction. The dross inclusion in massive form at the center of the specimen and the ribbon-shaped dross located longitudinally in the center of the reduced section had practically no effect on the endurance properties. The failures in the specimens containing these two types of inclusion did not occur at the defect but at the end of the reduced section. The failures of the other two specimens occurred through the defects.

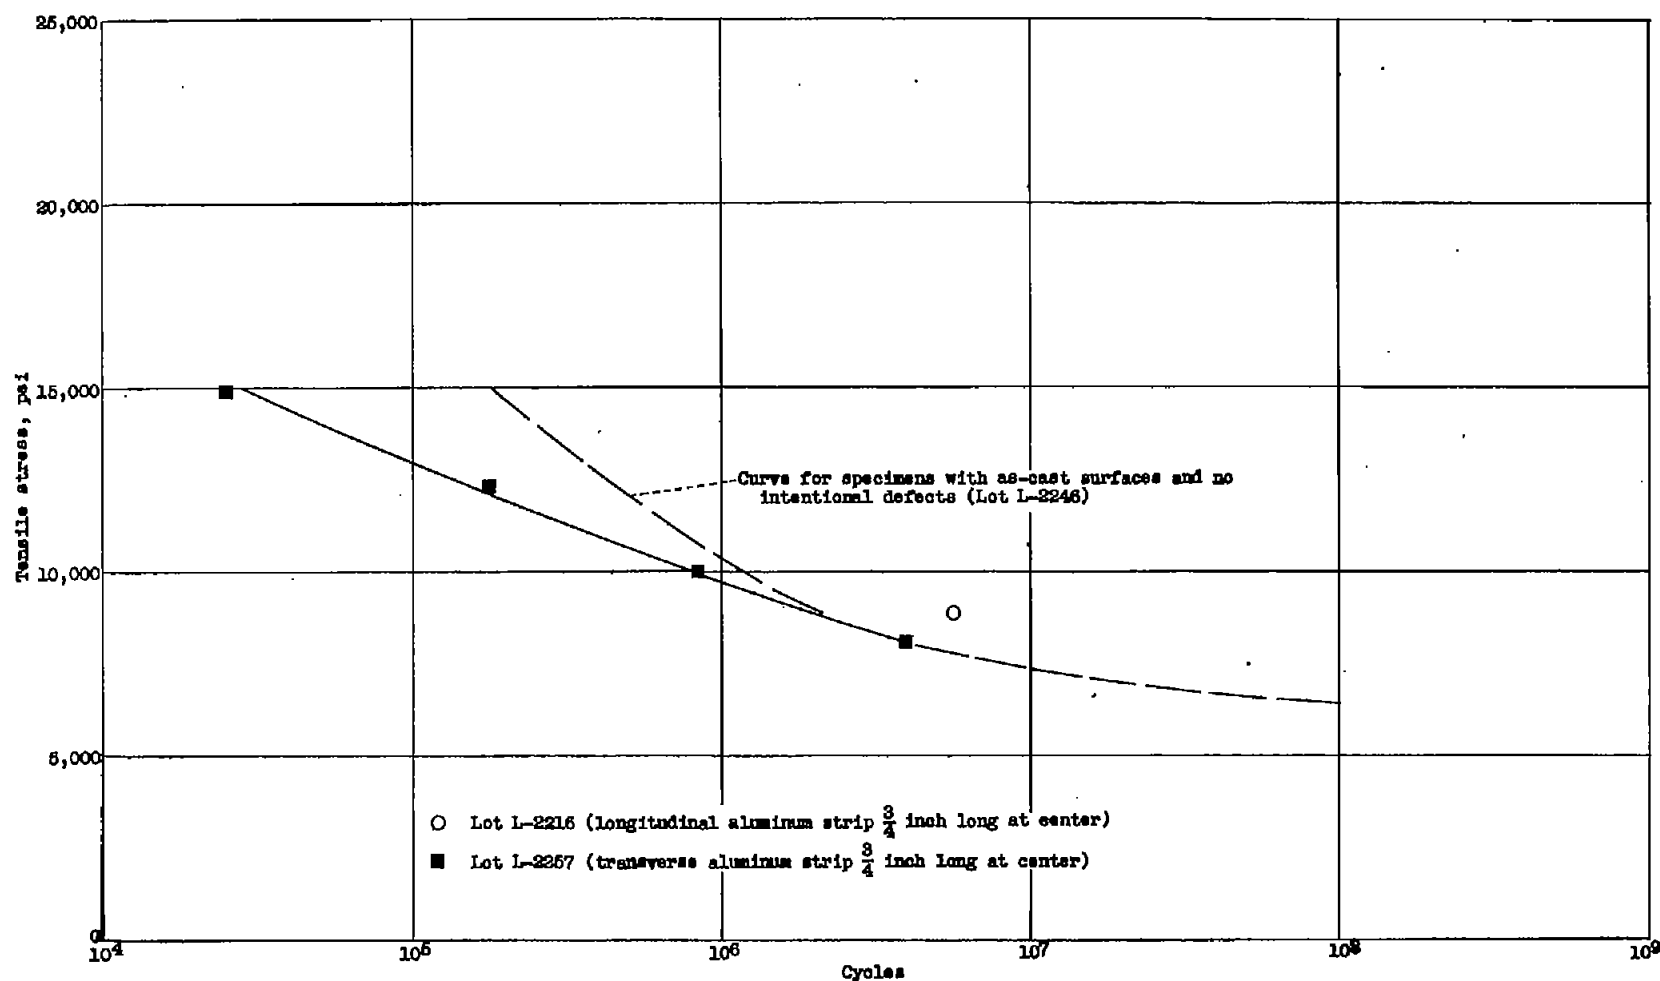
Figure 5(g).- Direct-stress fatigue curves for 355-T6 sand-cast specimens. Ratio of minimum stress to maximum stress equals zero.

Five specimens were cast with metal inserts at the center of the reduced section to simulate defects. The inserts consisted of aluminum strips  $\frac{1}{16}$  inch thick,  $\frac{3}{4}$  inch long, and having a width equal to the thickness of the specimen. In one of the specimens the plane of the strip was

in the longitudinal center line normal to the surfaces of the specimen; in the other four specimens, the strips lay in a transverse plane. The effects of these intentional defects are shown in figure 5(g). When the strips extended transversely, the harmful effects appeared greater at higher stresses but were quite small when the fatigue life was more than 1,000,000 cycles. All but one of the specimens with transverse defects failed through the defect. When oriented longitudinally the defect had little or no harmful effect on the fatigue life. The failure did not occur at the intentional defect but at the end of the reduced section.

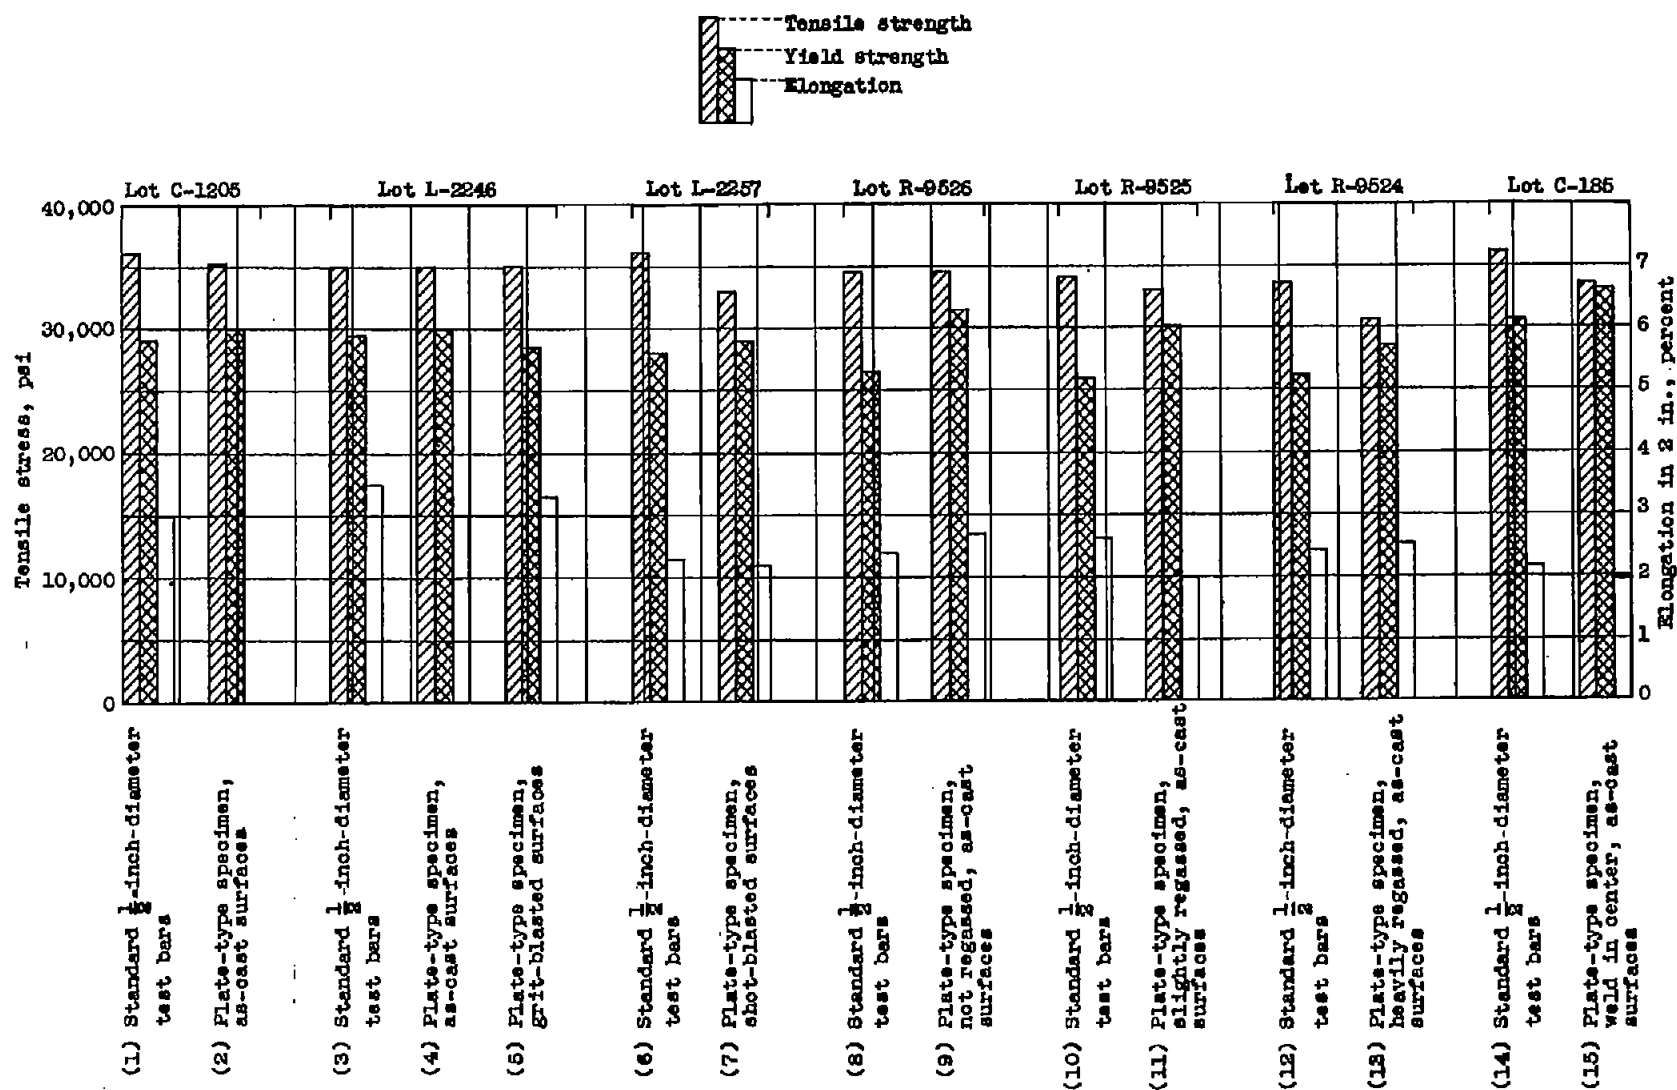
Figure 12.- Results of tensile tests of test bars and plate-type specimens of 355-T6 alloy. Specimens (4), (5), (7), (9), (11), (13), and (15) previously subjected to a fatigue test of at least 25,000,000 cycles. Specimen (13), tensile strength low because specimen failed through defect.

The results of the tensile tests are summarized in table VII and are shown graphically in figure 12. In this figure, the results of the tests of the separately cast test bars are shown for comparison.
